A performance assessment of a R/C frame building using a record obtained at its foundation

P. Bonelli & M. González

ICCRRR International Conference Concrete Repair, Rehabilitation and Retrofitting Nov. 2005 South Africa.

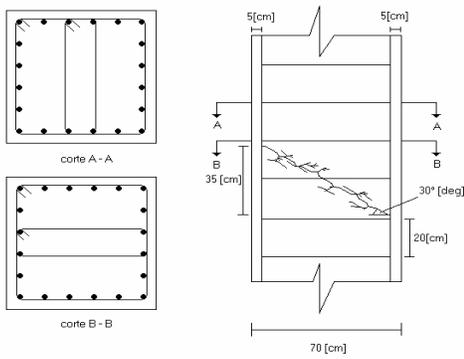
Fig. 2- Cross section of the columns and ties arrangement.

Existing columns have double 10-millimeter diameter ties spaced every 20 centimeters. Interior ties have been placed alternating their direction. Thus if shear forces produced a crack with an inclination of 30 degrees, the arrangement of the reinforcement requires only two of 10-mm diameter to resist the shear forces, as shown in figure 2. Severe corrosion of the transverse reinforcement

at the base columns was observed during an inspection of the building (Boroschek, 2000). Also the number and disposition of existing ties did not comply with modern ACI 318 codes. Therefore, the analysis considered that the shear strength of the main element is only due to the contribution of the concrete.

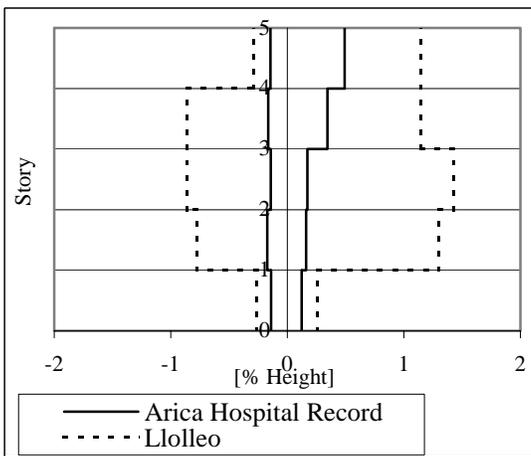
Fig. 6- Maximum Interstory Drifts

ABSTRACT: A six story R/C frame building suffered non structural damages under the 2001, Mw=8.4 South of Peru Earthquake, losing functionality. One Earthquake record was obtained close to the building base with a local peak acceleration of 0.3 g. The building is a typical 1970's limited ductility moment resistant frame. After the 2001 event the building was abandoned and a retrofiting project was proposed. In this paper, the damage pattern of the building after the 2001 event is compared with results of a non-linear analytical model made with the record obtained at the site. In general, results of the analysis match the observed behavior. Computed shear demands in columns were lower than the estimated column shear capacity, cracks appeared in beams where yield was expected. Maximum interstory drifts can be related to damage in non structural elements.

Observed damages under the 2001 South of Peru Earthquake in the building match the analytical results obtained using the record registered close to the building. Cracks observed in beams of the building suggest that they effectively yield. Columns appeared undamaged but they would have been very close to a shear failure. The vulnerability study proved that they are very vulnerable to a brittle catastrophic shear failure under more severe earthquakes

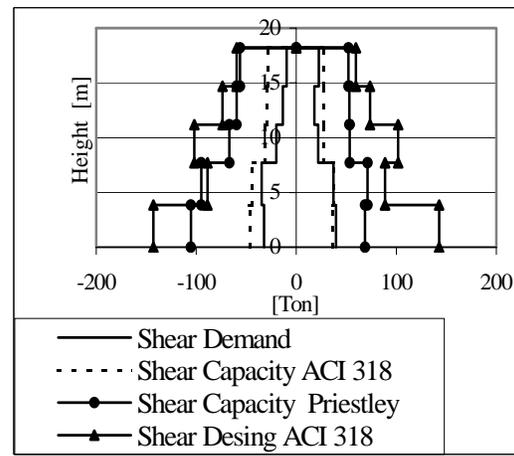
Fig. 9- External Column Shear. Arica Hospital Record

Figure 9 contains four curves. The maximum shear in external columns obtained from the non linear analysis is compared with the shear capacity calculated in two different ways: i) the ACI318 Code shear capacity taken from expressions (11-7) and (11-8), art. 11.3.2.2 of ACI318-2002, only considering the concrete contribution to shear resistance, and ii) application of the expressions proposed by Priestley et al (1994). The demanded shear forces in columns were calculated with the AH record. The results revealed that the shear demand was very close to the calculated shear capacity. This means that some columns could have failed in shear under this earthquake according to the ACI318 expressions. The performance point of the original structure was drawn in figures 3 and 4 proving that it is very close to the seismic demand. However Priestley's expressions give higher values to the shear strength in columns, being the response satisfactory for this record as actually occurred in the building. Nevertheless the columns do not comply with ACI318-2002.

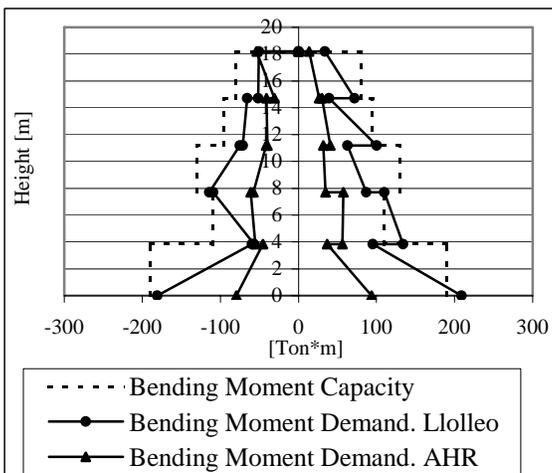
Fig. 7.- External Column Bending Moments

moment demands with flexural capacity in columns showing that they effectively remained elastically during the earthquake, but could have yielded in upper floors under a Llolleo earthquake. Unfortunately, the low column shear resistance does not allow the bending capacity to be developed. The failure mechanism is controlled by column and beam shear failure at very low lateral displacements.

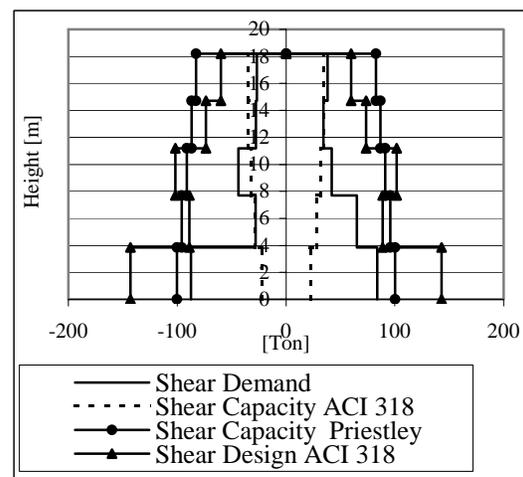
Fig. 10- External Column Shear. Llolleo

Figure 10 presents the shear demands for the Llolleo record, confirming that a brittle shear failure in columns could be expected under a severe earthquake in the area. In consequence, a retrofit strategy should be implemented or the building must be demolished.
