## **Experimental Determination of Damping Ratio of a Transparent Pier with Steel Piles and Reinforced Concrete Board**

### **SUMMARY**

This paper presents the results of Pull-Back tests realized during December, 2002 in Port Ventanas, one of the main solid and liquid bulk ports located at Quínteros harbor, V region of Chile. The tests objective was to determine the damping ratio of a transparent pier of steel piles and reinforced concrete slab. The access bridge of the pier was constructed in 1964 and it has 375 mts. length and 8.3 mts. width. It consists of five independent decks with trestle support structure, in which are supported pipelines for fuels, asphalts, chemicals, sea water intake, and different types of conveyors belts. Every deck is formed by a slab of 30 cms. of thickness, steel girders inserted in concrete and steel piles. To realize the tests a steel pull back system was made, installed in longitudinal direction in between two decks. It consisted mainly of a hydraulic jack, four steel flat bars, fuses and two steel base plates with bolts anchored set to the floor slab. Its operation was realized through the hydraulic jack, generating the forces through the syste

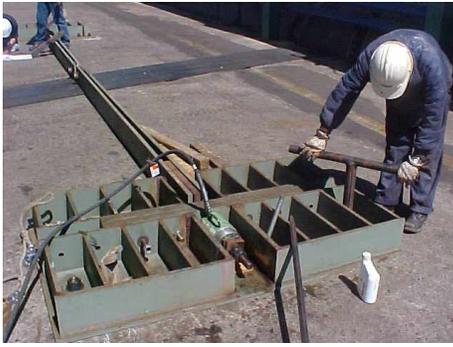
Fig 9 Final tighten of nuts to the floor slab

Finished the previous thing, the shot system was located again and bolts were tighten definitively. The final tighten was made in the day of the test, previous general inspection. The required time in all this process was smaller than the real one, since the test had to be postponed several times, reason why there was time to solve each problem. The scaffolds were dissambled in order to not interfere during the test. For the day of the test the hydraulic cylinder was put in the shot system, wich was under technician support. Also, he realized tests in laboratory in Santiago, where he assured about the well functioning of pressure hoses and obtained the maximum force that the cylinder could give during the test, this value was 52 ton. The pressure hoses had 10 meters length approximately. This was due to protection rules were taken. Since it could happen that during the test the shot elements, of around 4 mts. of length, they could stand up or parts of the fuse were cut suddenly and then explote. A remote possibility but not impossible to happen. Reason why the technician, the nearest person to the shot system had to protect himself. This was made with hoses extension and protection with sand bags, in the place wich he would be located.

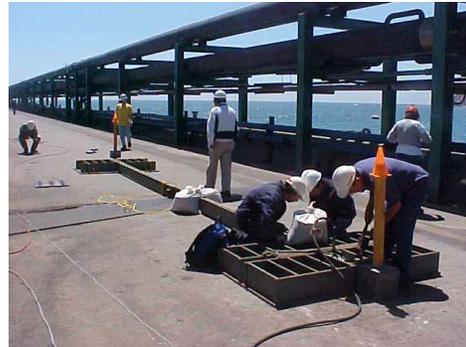
Fig. 10 Location of the shot system

A first layout was made in the floor slab, in the edge of the decks 3 N° and N° 4, of the access bridge, marking the main axle and the location of the two main plates. Concluding this, it was placed all the shot system on the floor slab according to the layout, it means the two main plates the shot elements and the fuse in the center, at the edge of the two sections. For this, it was asked for a cargo crane for transporting the main plates of around 200 kgs., weight each one. Located all the system, it was come to mark the points of perforation on the floor slab. 32 perforations would be made. It was observed that everything were well located according to the plan and proceed to remove the shot system for perforating the floor slab. Made the previous thing the, it was requested to the port for positioning two scaffolds in the two edges of the two decks. These ones were placed under the board floor slab and their main function were help in the perforation and later in the positioning of the inferior plates, nuts and the passage of boltswich would be tightened over the floor slab.

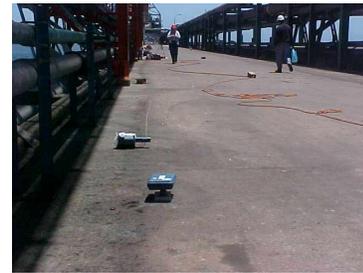
Fig. 12 Location of seismometers

For microvibrations measuring 4 speed sensors were settled (seismometers), Kinemetrics brand, Model Ranger SS-1 as a whole with a system of data acquisition IOTECH brand, Model Daqbook 200. This system registered the history of speed of each sensor in parallel form (common time) and stored them, in digital form, for its later processing. The signals processing was made using a temporary program and spectral analysis. The speed sensors anchored to the superior part of the board and they were connected at the same common time, placed throughout the deck N° 4.
