A performance assessment of a R/C frame building using a record obtained at its foundation

P. Bonelli & M. González

ICCRRR International Conference Concrete Repair, Rehabilitation and Retrofitting Nov. 2005 South Africa.

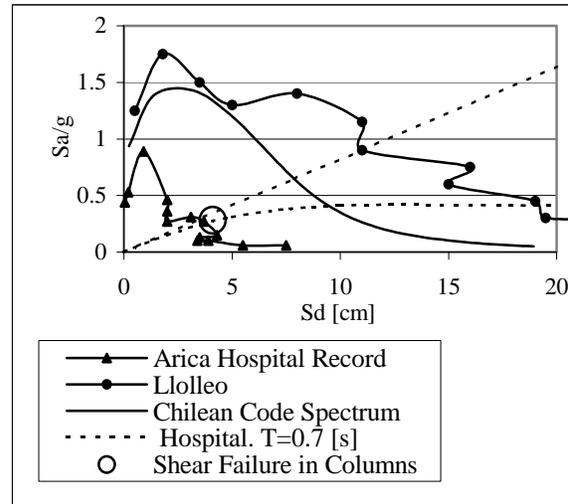
Fig. 3- Capacity Spectra . $\xi=2\%$

Moderate structural damages were observed but non-structural damages resulted in the building functionality loss. The Hospital was evacuated, patients were moved to an old 1940's two-story confined masonry building next to the Hospital that suffered no damage. Figure 3 and figure 4 compare capacity spectra of the AH record, Llolleo 1985 record and the Chilean Code Spectra. These figures also include the building capacity curve. Natural periods were obtained from analytical and ambient vibration studies.

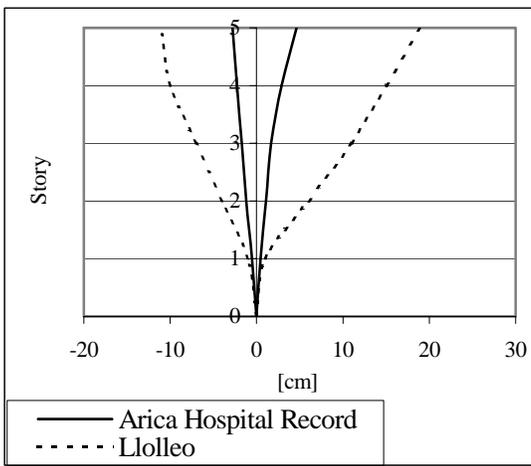
Fig. 5- Lateral Displacement Envelopes

Non linear analyses were carried out with the Ruaumoko computer program. The AH record was used to verify if analytical results matched the observed behavior. The Llolleo 1985 record was applied to evaluate the possible building performance under a severe earthquake that could affect the area. Figure 5 shows lateral displacement envelopes and figure 6 the maximum interstory drifts calculated for both records. Thin cracks appeared in the building at the beam-column face specially on the first and second floors but according to the analytical predictions most beams of the upper floor should have yielded under the Arica Hospital record. Figure 7 compares the bending

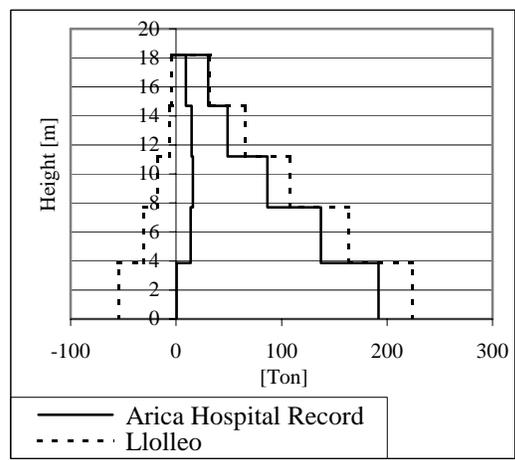
Fig. 8- External Axial Force

A_g is the gross area, A_e the effective area ($0,8 A_g$), M the bending moment, V the shear and D the diameter of the confined concrete area. P is the axial compression force. The shear capacity was evaluated for the corresponding axial force obtained by the non linear analysis. Figure 8 shows that for the Llolleo record axial forces are slightly higher than for the Arica Hospital record.
