## Chile Resiliency: a Review of the Housing and Health Sectors

Ruben Boroschek<sup>1</sup> and Rodrigo Retamales<sup>2</sup>

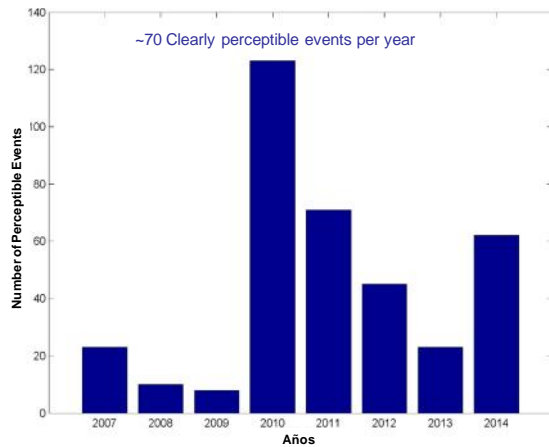
Figure 1. Number of events IMM > V.

Chile is one of the countries with the highest seismic activity in the world, primarily due to the subduction process of the Nazca Plate below the South American continent. From the late 16<sup>th</sup> century to the present, there has been a high-magnitude damaging earthquake ( $M_w > 7.5$ ) every 8 to 10 years on average throughout the Chilean territory. Figure 1 shows the statistics of seismic events with Modified Mercalli Intensities IMM greater than V occurred between 2007 and 2014 in the Chilean territory.

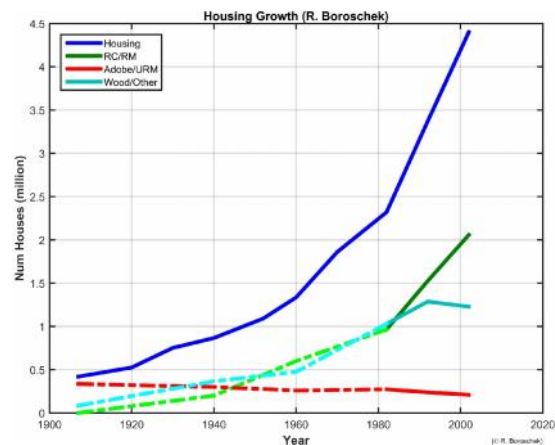
Figure 2. Housing growth per construction material.

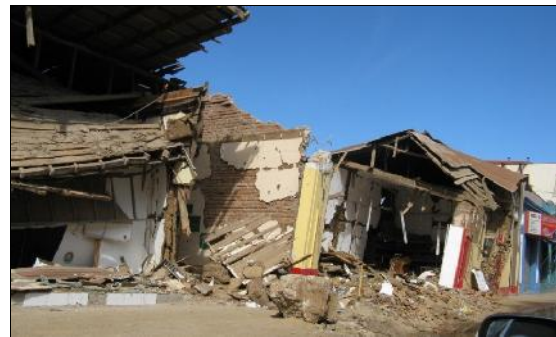
Figure 3. Typical damage non engineered structure.

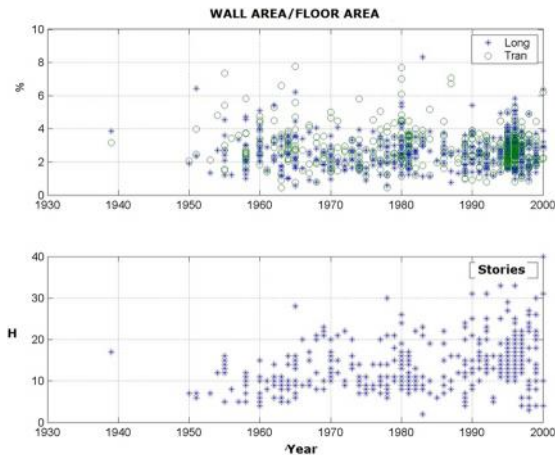
Figure 4. Evolution with time of wall area to floor area ratio and total building height (after Calderon 2007).

and contractor and mandatory peer review requirement for all structural design projects with more than 4 stories high. Additionally, the code strict inter-story drifts limits, which typically results in the need for using reinforced concrete shear walls or mixed systems composed by moment resistant frames and shear walls has contribute to a very low damage level. Moment resistant frames without shear walls are not feasible in the Chilean practice. Figure 4 shows the evolution with time of the ratio between the in-plan shear wall area and the total floor area, and the evolution with time of total building heights (after Calderon 2007). It is observed historically the wall density ratio has fluctuated between 2 and 4%.

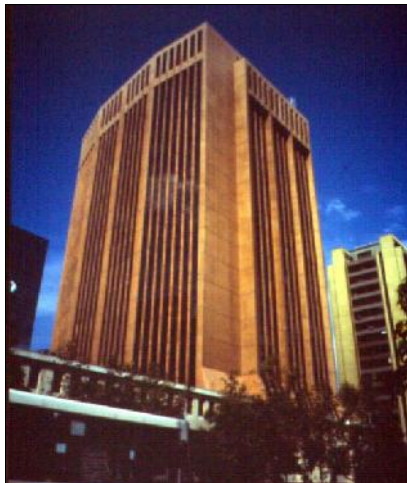
b) Photo modern construction

Figure 5. Chilean Chamber of Construction building. (S. Contreras)

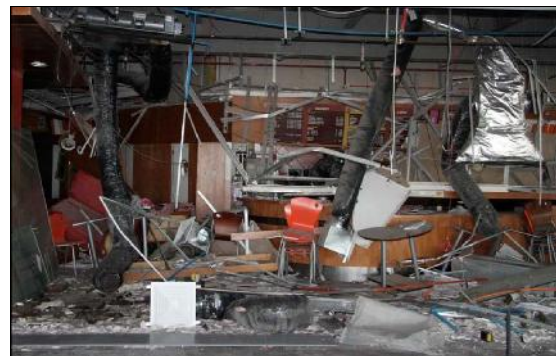
Figure 7. Example of generalized damage to non-structural components and systems (Miranda et al., 2012).

The February 27, 2010  $M_w$  8.8 Maule earthquake (Figure 6) affected a significant portion (65% of stock, approximately) of housing and health infrastructures, causing economic losses exceeding 33 billion US dollars, equivalent to 15% Chile's 2010 GDP. Ninety percent of those losses were associated to nonstructural damage (Figure 7).

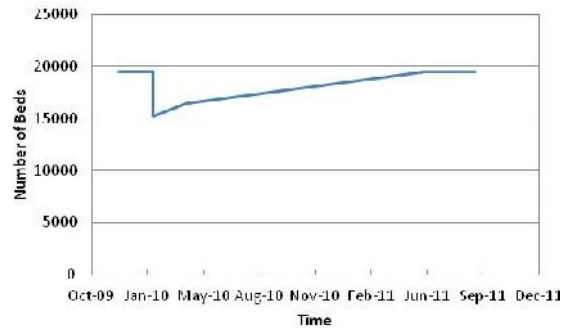
Figure 10. Recovery process for beds in affected area. (after MINSAL)

Figure 10 shows the recovery function of the number of beds available in the affected area. In Figure 10 it is observed that recovering the number of beds available before the  $M_w$  8.8 earthquake took 14 months.

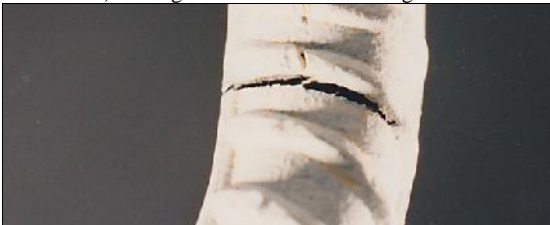
b) Low cycle fatigue longitudinal rebar (Photo: J Restrepo)

Figure 8. Damage to structural components.

Structural damage was observed in approximately 0.5% of buildings, including damage to shear bearing walls due to deficient confinement detailing, excessive slenderness of the walls, low cycle fatigue of longitudinal rebar, excessive vertical compression loads, walls discontinuities and wall/slab interactions (Boroschek et al. 2014). Figure 8 shows examples of the observed structural damage. Ten percent of the losses (3.3 billion US dollars) resulted from direct damage to the 130 public health facilities affected.

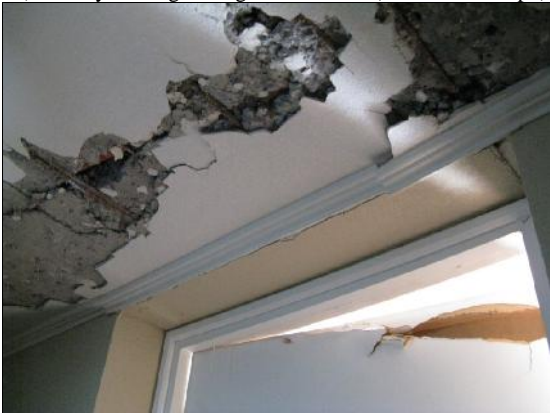
c) Damage due to wall/slab interaction
